# **FIELD INVESTIGATIONS OF UNCONTROLLED HAZARDOUS WASTE SITES**

**TASK REPORT TO THE  
ENVIRONMENTAL PROTECTION AGENCY  
CONTRACT NO. 68-01-6056**

REMEDIAL APPROACH PLAN  
FOR  
LEES LANE LANDFILL  
LOUISVILLE, KENTUCKY

TDD F4-8109-08A

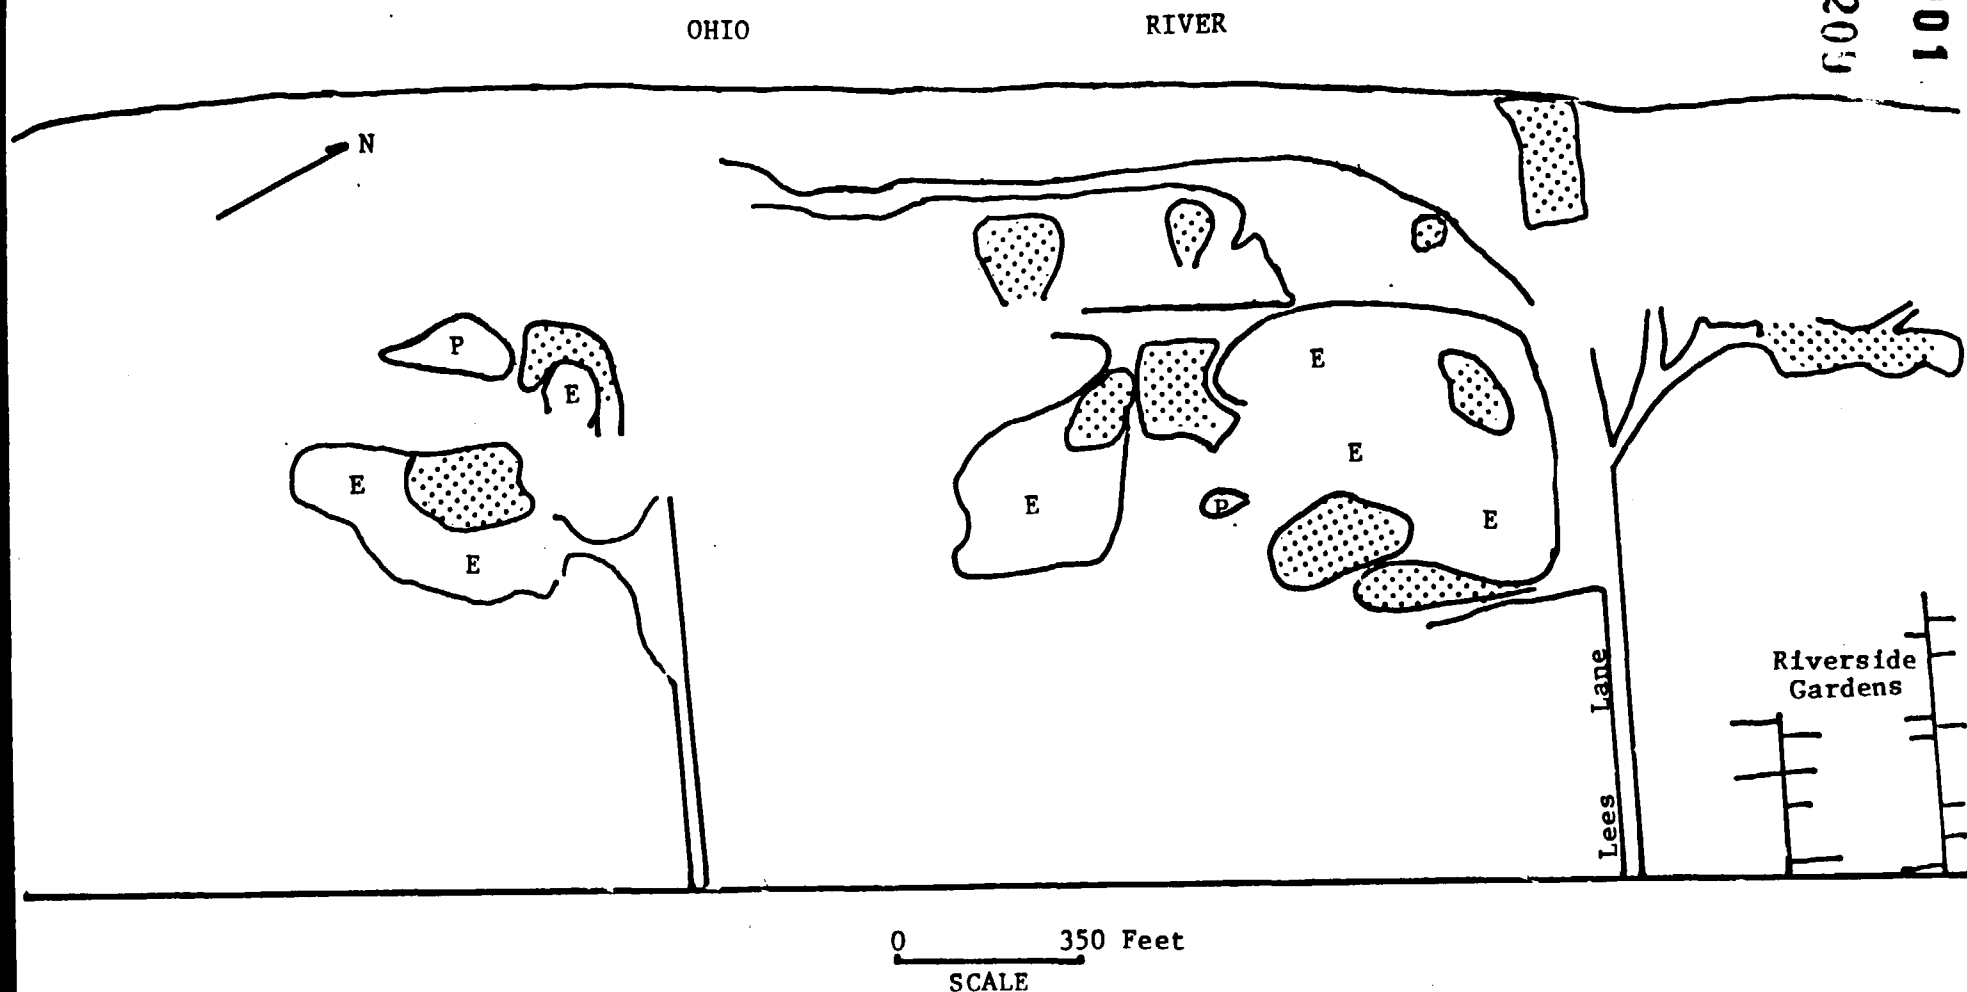
Ref: Aerial Photographs April 1963, Park Aerial, Louisville, Kentucky

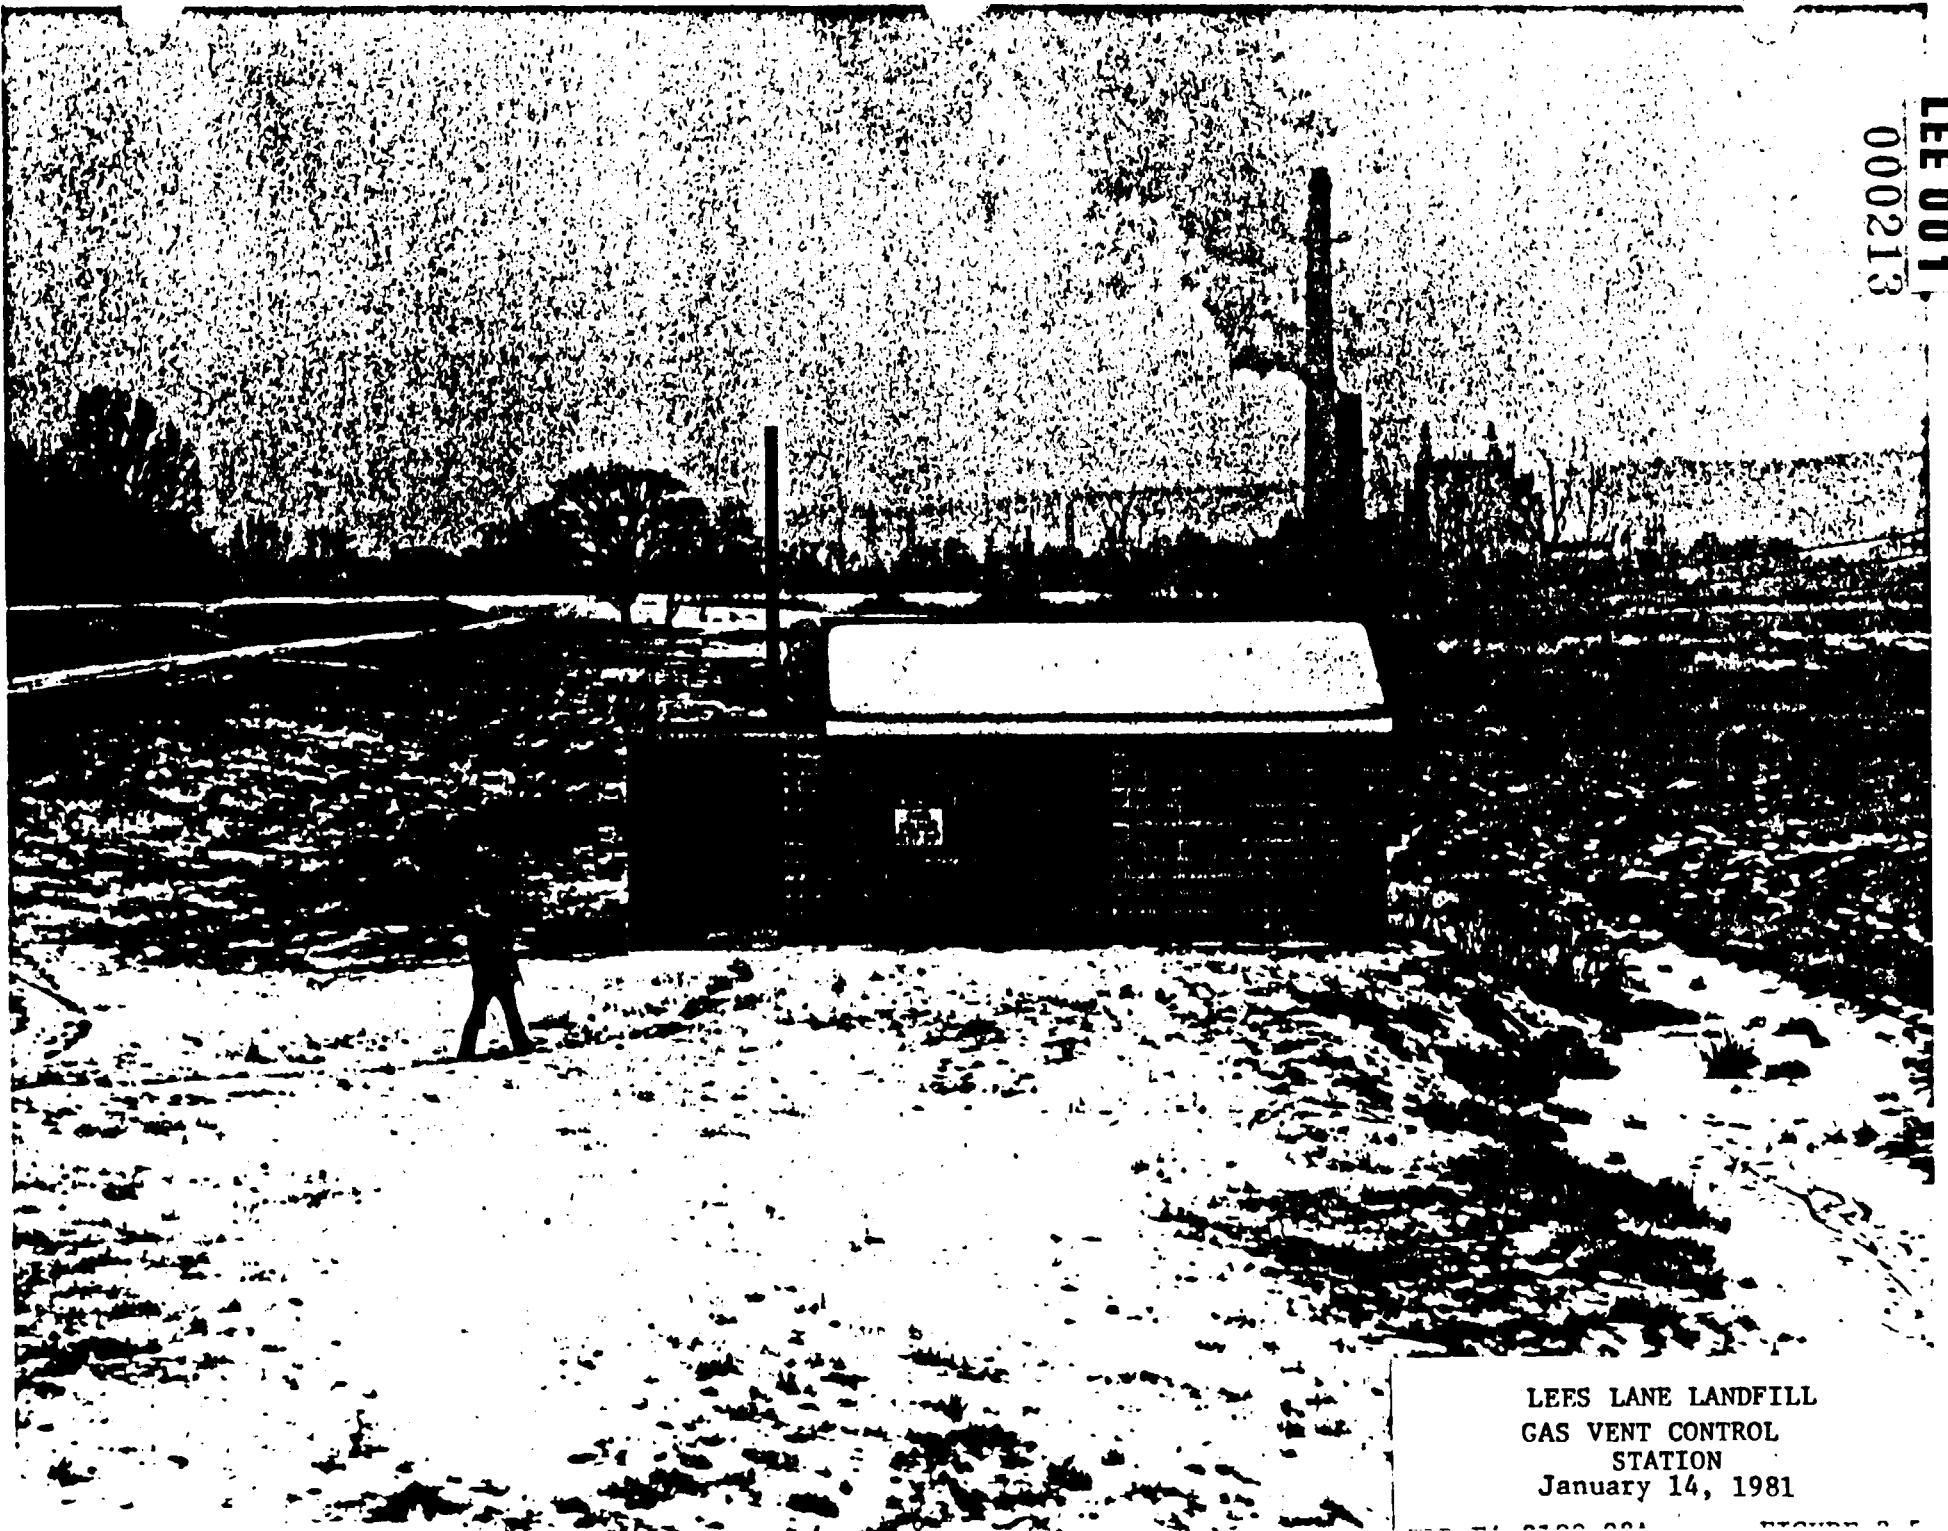
LEES LANE LANDFILL  
GAS VENT CONTROL  
STATION  
January 14, 1981

In March of 1975 the migration of methane gas to the nearby community of Riverside Gardens caused the temporary evacuation of families in that area. This problem was finally solved in 1980 with the installation of a gas venting system to vent the methane gases that accumulated under the landfill. Although the explosive and fire potential from the accumulation of methane gas has been remitted, the gases emitted presently enter the atmosphere.

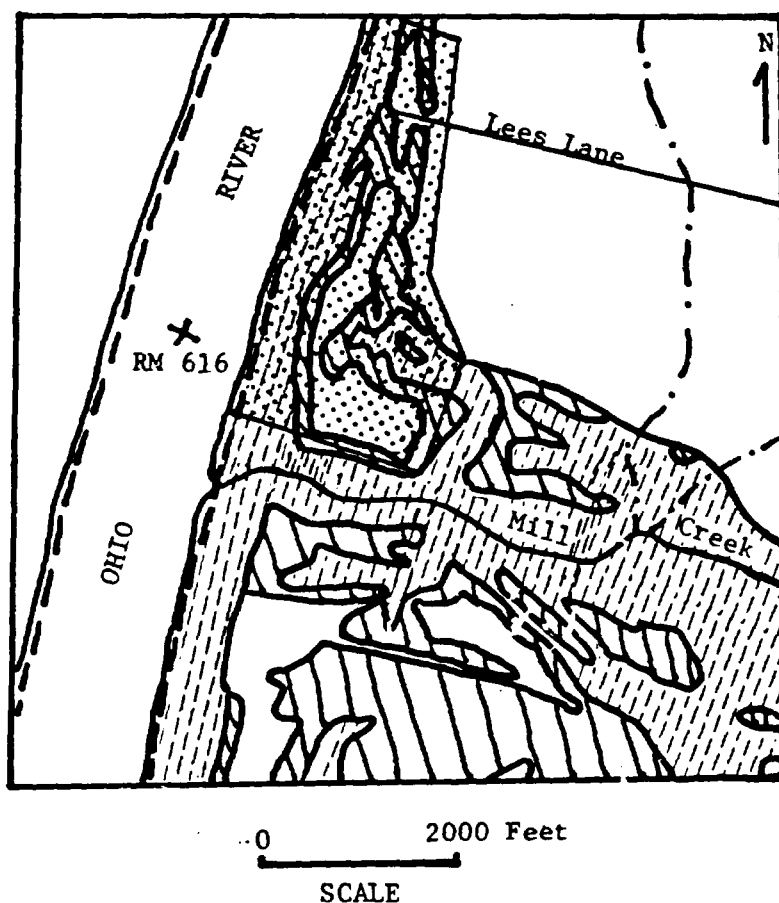
LEGEND	
	Lees Lane Landfill
	500-Year Flood Boundary
	100-Year Flood Boundary
	Floodway Fringe
